## Tui Glen Picnic Table & Shelter construction RETROSPECTIVE REPORT

CR Ken Turner

## 1.0 Overall Summary

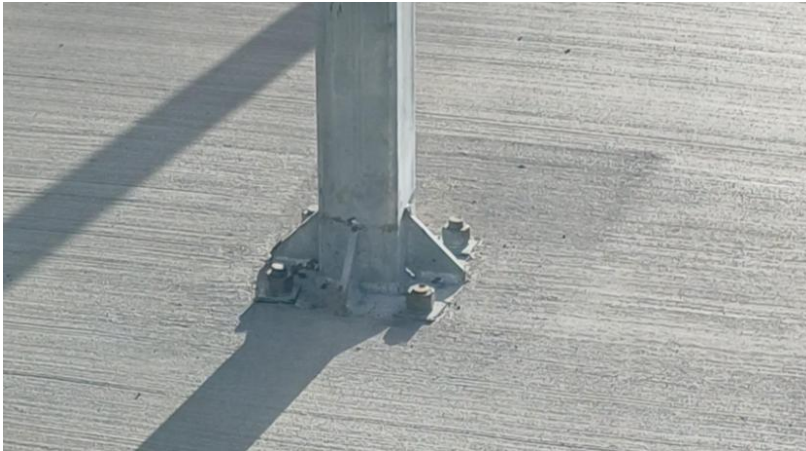
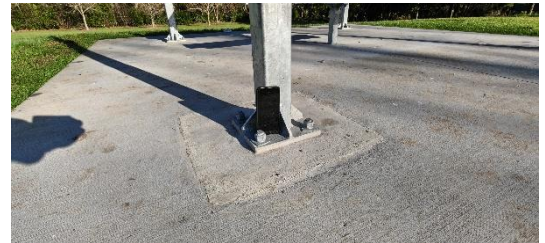
Retrospectively piles were then installed and the frame erected. The concrete 'cover' was then required to be relaid as the inconsistencies in the newly installed piles gave a poor aesthetic finish.

So, the basis of Council's complaint was cosmetic.

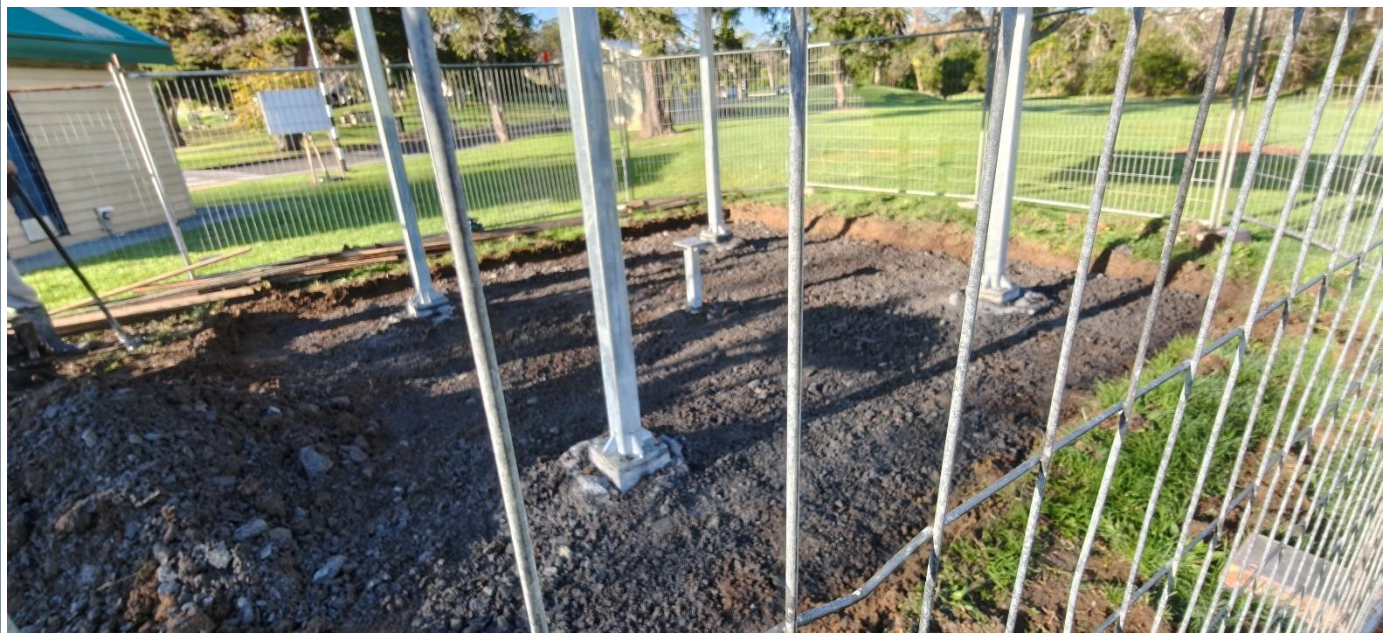
And this is the real reason the new concrete pad was broken up and removed. When the more robust foundations were retrospectively installed by cutting holes in the pad, no inspection took place. Subsequently, no one would sign off the foundations because they couldn't be inspected.

I was told that the pad was removed to remedy structurally unsound foundations, and once that was finished, the shelter structure would be placed back on the new foundations. But again, the reality on the ground was different. The shelter structure was left standing on the foundations.

I understand that, as it is now possible to inspect the foundations of the first structure and it can be assumed that the second structure has been constructed in the same way. Therefore, the second structure's concrete pad may no longer need to be removed.

5.0 A number of remedial measures were subsequently undertaken, including:

- Cutting and patching around the foundations.
- Concrete grinding.
- Acid washing.
- Installation of an additional concrete overlay.
- Demolition and reconstruction of affected slabs.

Each remediation attempt was considered unsatisfactory by AC, resulting in the decision to remove and replace the affected slabs – this has been partially completed (LHS only – RHS remains to be completed).

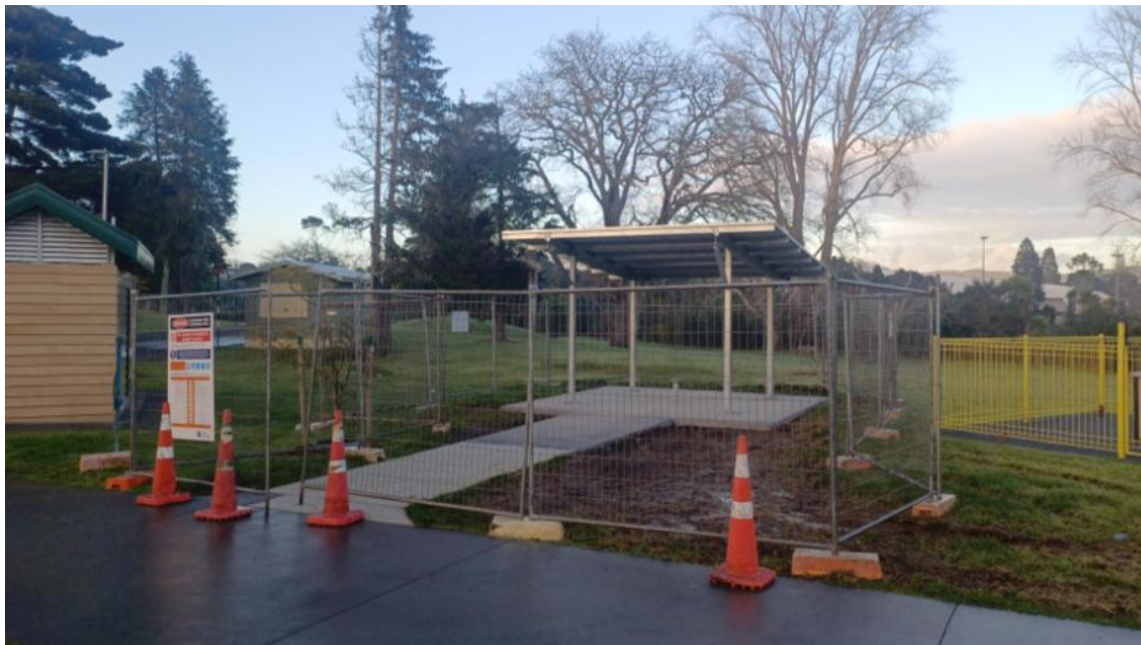
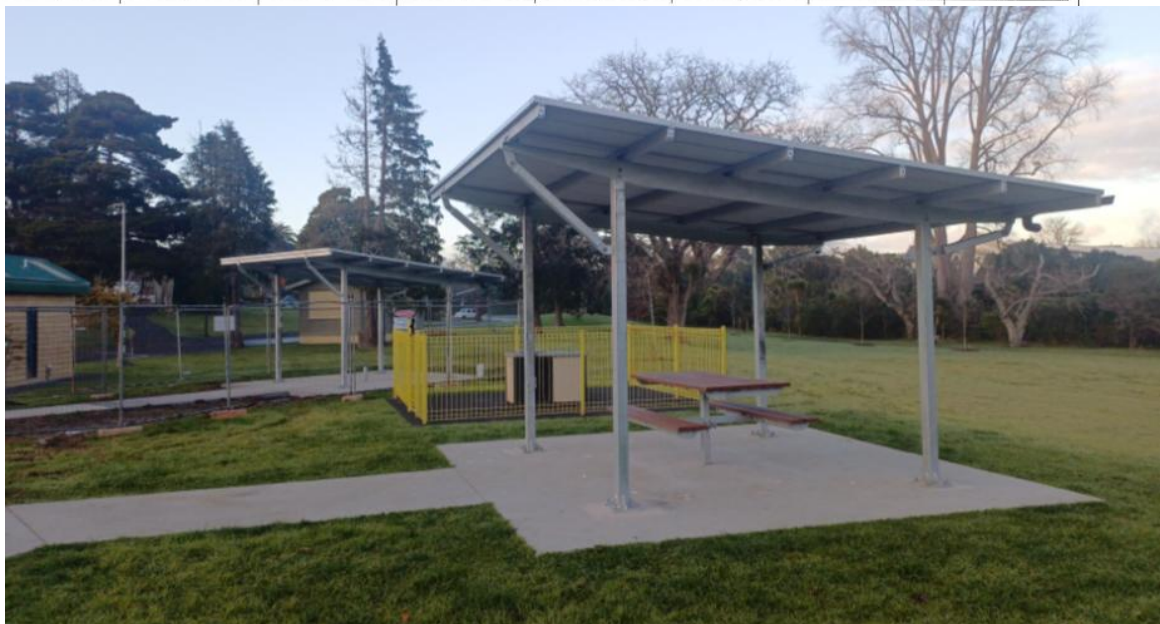
**Tui Glen West Auckland**

**And so much for the Mayor's standardisation policy**
